Archaeological Site and Reservoir Shoreline Stabilization Using Wetland Plants and Bioengineering, Rice Reservoir, Wisconsin

by Cathy J. Wendt and Hollis H. Allen

PURPOSE. This technical note describes a case study in which wetland plants and bioengineering treatments were used to protect an archeological site on an eroded reservoir shoreline and to stabilize the shoreline from further erosion. The site is called the Robinson Site and is located on Rice Reservoir in northern Wisconsin, about 26 km (16 miles) southeast of Rhinelander.

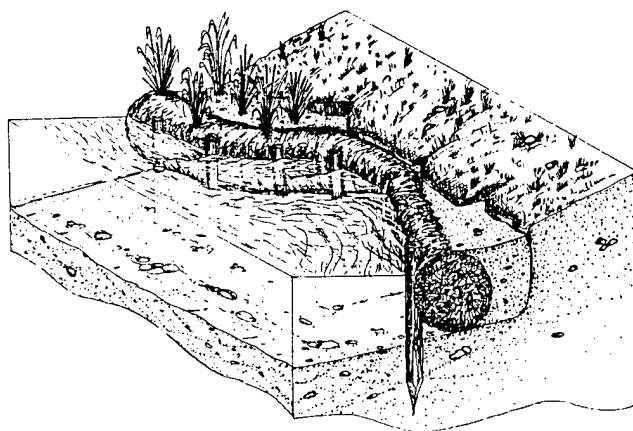
Fiber Roll Installation. Four 30-cm- (12-in.-) diameter and three 40-cm- (16-in.-) diameter fiber rolls were installed. Their configuration varied with the shape and height of the bank. A single 30-cm- (12-in.-) diameter roll was used where the bank was lowest and was positioned to "fit" under the lip of the existing undercut bank (Figure 3). As the height of the bank increased, fiber rolls were placed two and three high, resulting in a tiered structure. The fiber rolls were anchored in place with 1- to 1.2-m - (3- to 4-ft-) long wooden construction stakes made of 2 by 4's cut diagonally to form a longitudinal taper.

Figure 3. Fiber roll toe

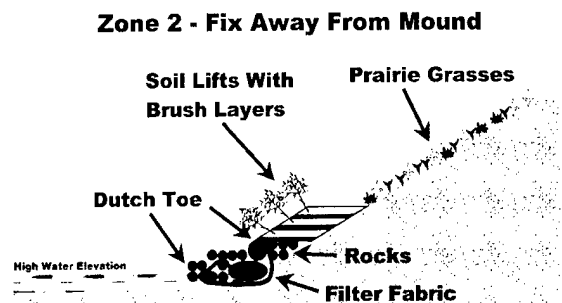
Figure 6. Fix away from mound area

erosion control blanket. The amount of fill was gradually reduced as the distance from the mound increased, thereby blending it into the previously existing bank configuration as illustrated in Figure 6. Where it was not already vegetated, the bank away from the mound area was hydroseeded with the same species of prairie grasses as listed above.

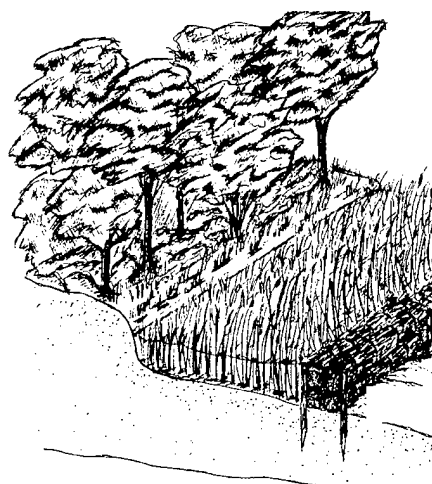
Branchbox Installation. The branchbox breakwater was built from cedar posts and brush during the April workshop. The breakwater is designed to be a temporary structure that diminishes wave energy while plants establish (Figure 7). The breakwater was positioned 4.5 m (15 ft) out from the bank (the maximum distance Wisconsin DNR would allow) with the ends bending back in toward the toe of the bank. The ideal distance for the breakwater would have been 9.0 m (30 ft) out from the bank. The branchbox breakwater will be maintained until shoreline stabilization occurs and will then be removed.

Figure 7. Branchbox breakwater lakeward of protected wetland plants

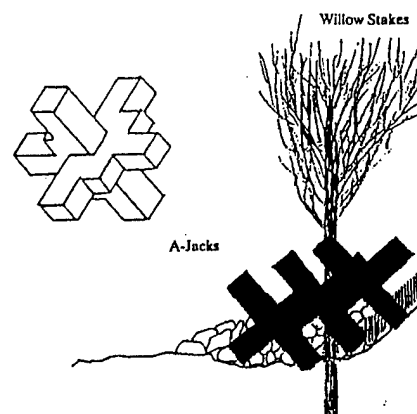
A-Jacks® Installation. The A-Jacks® were installed during the April workshop. They were placed in rows so that each A-Jacks® unit interlocked within each row and with the units in adjacent rows (Figure 8). Each A-Jacks® unit, when installed, has three 60-cm (24-in.) axes forming six 30-cm (12-in.) legs. The lowest rows of A-Jacks® were trenched in close to the base of the bank. Fibredam® was placed between the rows and in the crevices to reduce soil movement and encourage root growth through the A-Jacks®. Live native willow and dogwood cuttings were jetted into the structures in April. Pre-rooted willows (USFS stock) were planted between the A-Jacks® and the toe of the bank in mid-August. The A-Jacks® were backfilled in September with a soil/rock mixture.

Figure 8. A-Jacks® toe

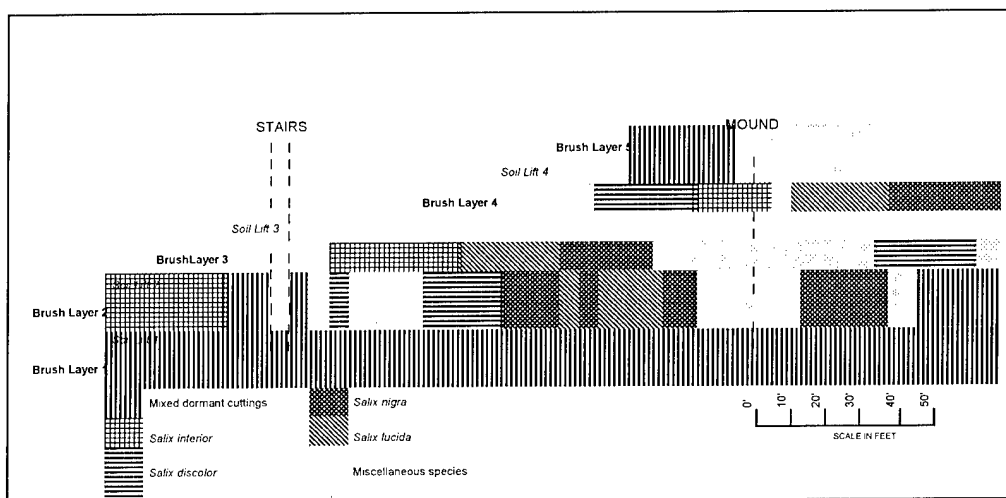
The transect method determined the survivability of the woody species by measuring 100 percent of the brush layers along transects. Survivability was determined by dividing the living stem occupation along the transect by the linear distance of materials originally planted. Each of the five layers was mapped (Figure 11) according to the species originally planted in the geogrid. Planting dates and harvesting dates were recorded. Portions of each brush layer consisted of different species (some were pre-grown in brush layer mats and some were installed as dormant cuttings). The species pre-grown in the brush layer mats were carefully monitored so valid comparisons between species could be made. The dormant cuttings were not differentiated by species but were intentionally mixed to increase the brush layer's chance of survival. Five

Figure 11. Diagram of brush locations in the geogrid

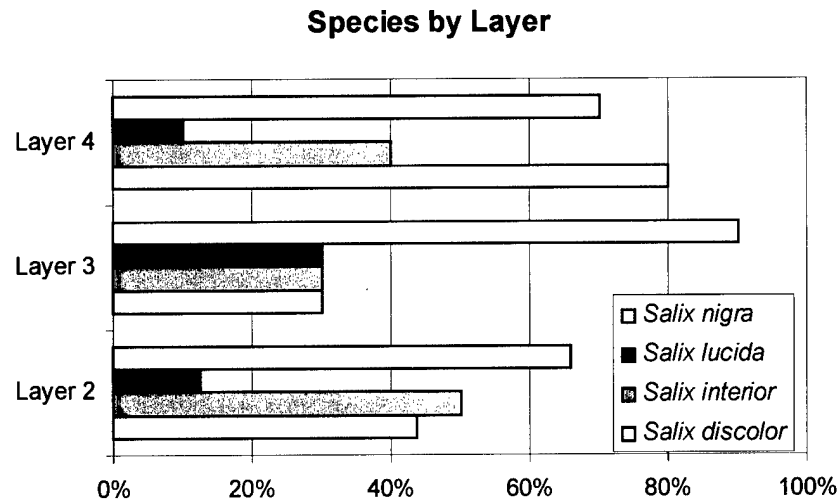
Of the 85 pre-grown brush layer mats, 73 contained the six native species. The placement of the mats on the bank was designed to test survivability of these species (Figure 12) under differing conditions within the site. *Cornus stolonifera* was not included in the comparison since an adequate amount of material could not be located. One native willow species, *Salix rigida*, performed poorly in the greenhouse and was also eliminated from the comparison. The 19 mats containing these two species plus 12 mats containing USFS stock are designated as miscellaneous species on the layout map (Figure 11) and were used to fill in the remaining areas among the four species being tested. The remaining four species demonstrated no apparent advantage or disadvantage to placement on the bank.

Figure 12. Plant survival by vegetative-geogrid height location by layer

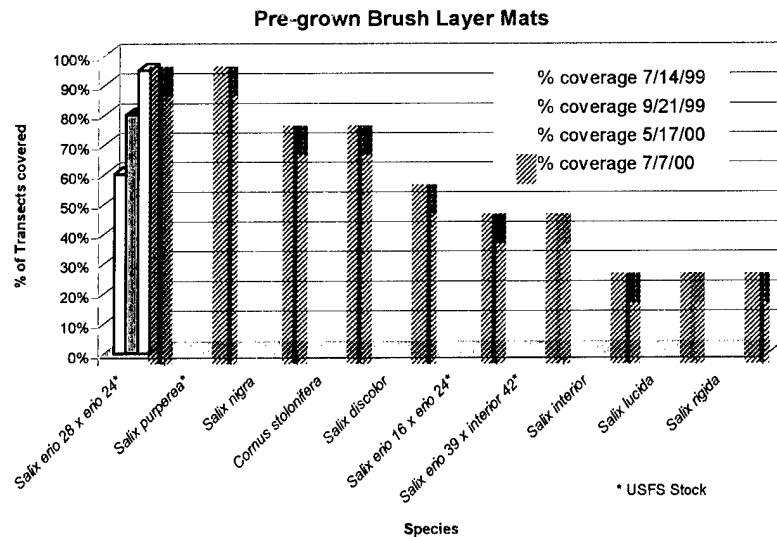
The transect method revealed a steady increase in the coverage for each pre-grown mat during the four testing periods from July 14, 1999 to July 7, 2000, with the exception of three mats (Figure 13). For one mat (*Cornus stolonifera*), coverage dropped by 20 percent between May 17, 2000 and July 7, 2000. The other mats were *Salix rigida*, which were already doing poorly in the greenhouse. Some mats showed increases as high as 60-80 percent, with an average increase of 23-percent coverage between July 14, 1999 and July 7, 2000. The species with the highest survival percentages were *Salix eriocephala* (90.0 percent) and *Salix purpurea* (90.1 percent) both from USFS stock. The native locally harvested species with the highest percentages were *Cornus stolonifera* (72.8 percent) and *Salix nigra* (72.7 percent). *Salix lucida* and *Salix rigida* had the lowest survival (17.7 and 16.5 percent, respectively). The overall survival rate of all pre-grown brush layer mats was 46.2 percent.

Figure 13. Performance (percent coverage) of brush layer mats by species

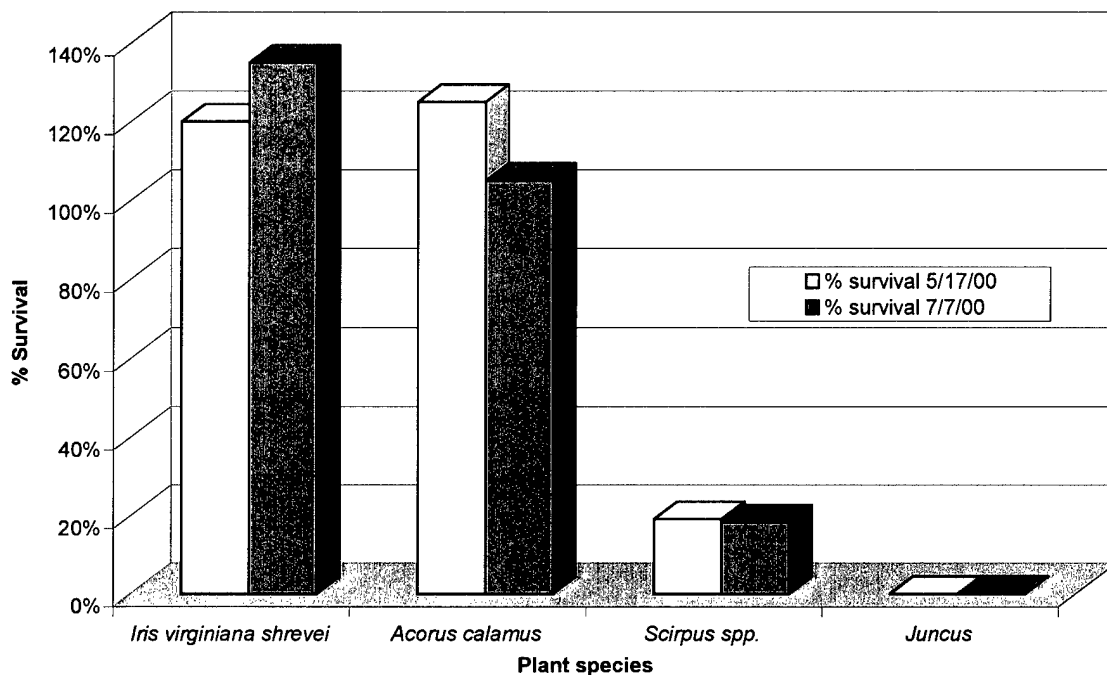
Of the planted species, *Iris versicolor* and *Acorus calamus* had the highest survival percentages when measured on July 7, 2000 (135 percent and 105 percent, respectively) indicating they have already regenerated. *Scirpus spp.* have not fared as well, having a combined survival percentage on July 7, 2000 of 18 percent. Of the 60 *Juncus* that were planted, none survived (Figure 15).

Figure 15. Survival of plants behind the branchbox breakwater
